**UNDERWATER FACILITIES
INSPECTIONS
AND
ASSESSMENTS
AT

U.S. NAVAL STATION

ROOSEVELT ROADS, P.R.**

FEBRUARY 1982

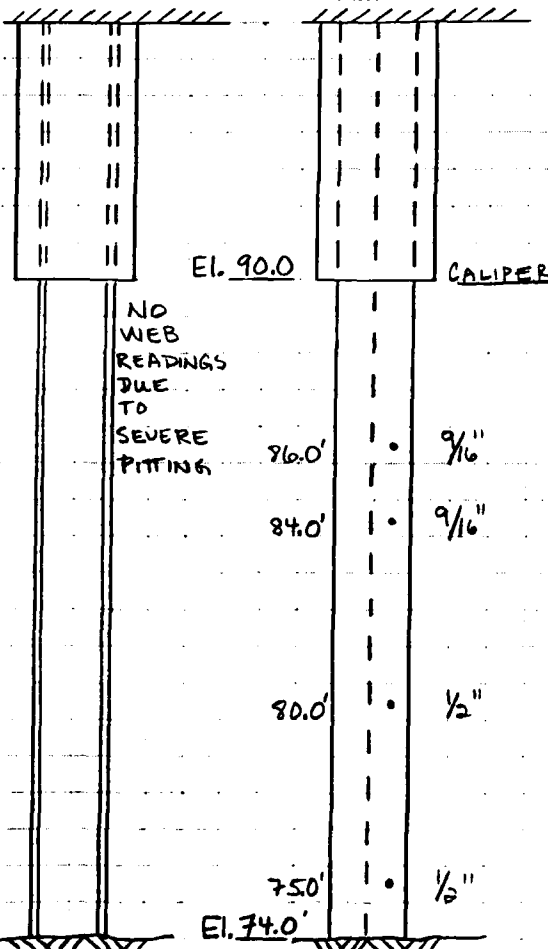
BENT 10 PILE A
PILE TYPE HP 14 x 89 (estimated)

ORIGINAL THICKNESS: ORIGINAL THICKNESS: .616"
WEB FLANGE

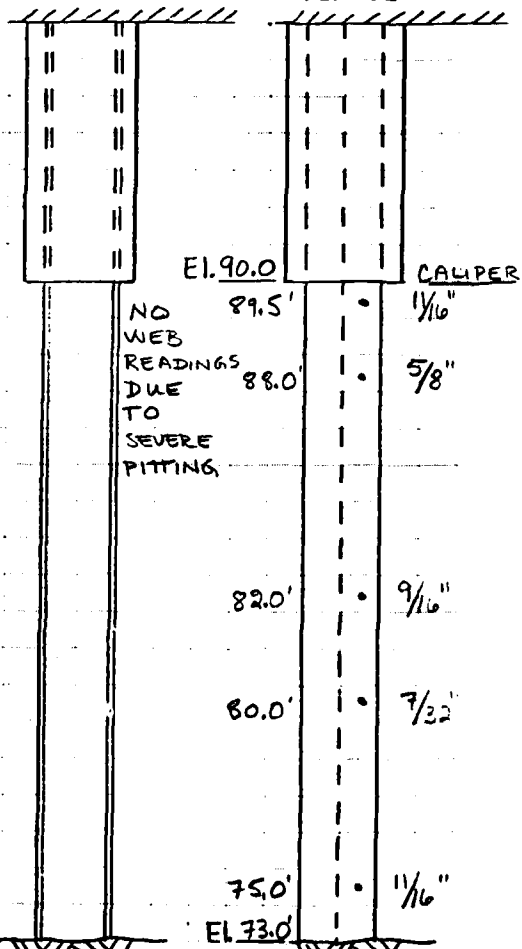
BENT 24 PILE A
PILE TYPE HP 14 x 102 (esti.)

ORIGINAL THICKNESS: ORIGINAL THICKNESS: .704"
WEB FLANGE

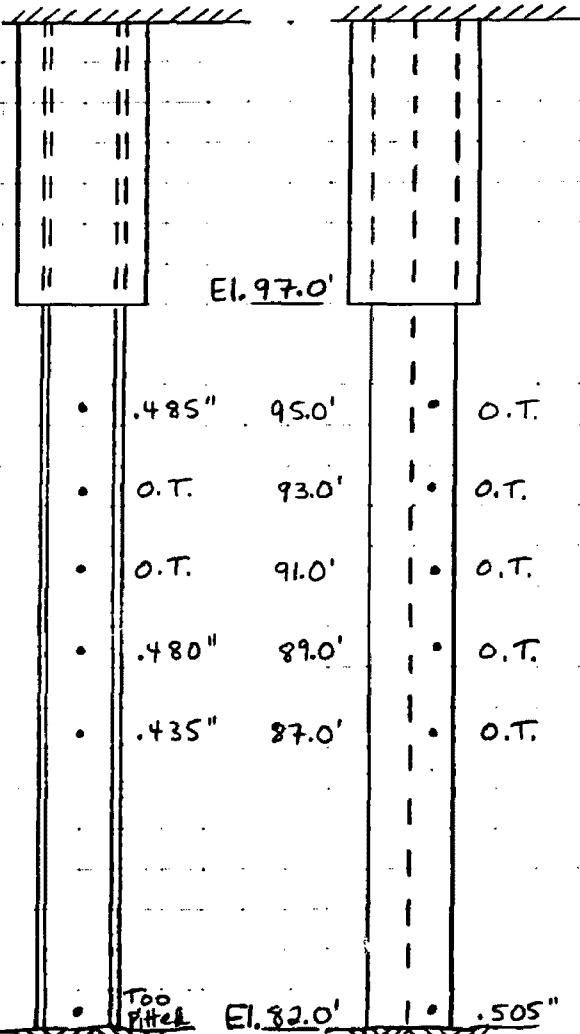
BENT 5 PILE T
PILE TYPE HP 14x73

ORIGINAL THICKNESS: .506" WEB
ORIGINAL THICKNESS: .506" FLANGE

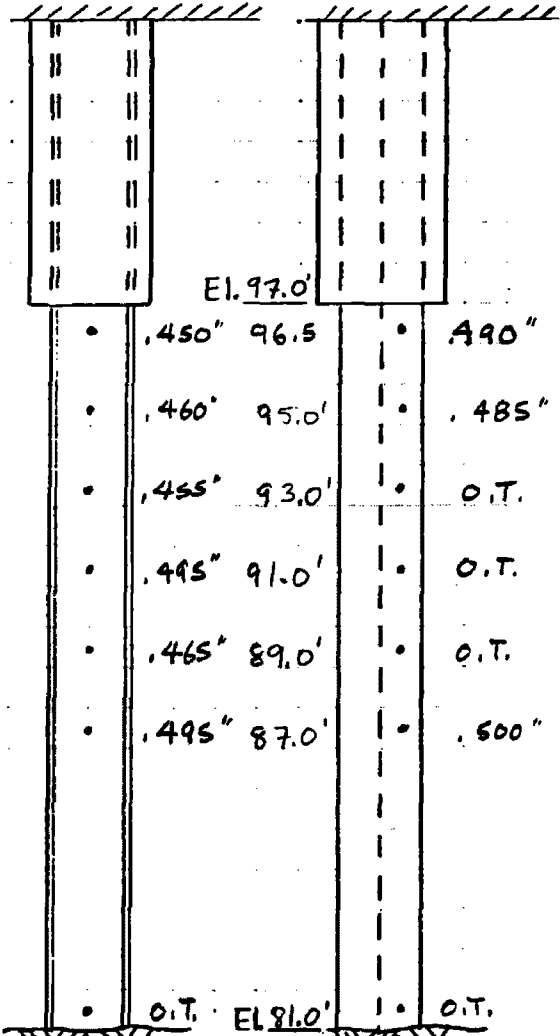
BENT 10 PILE T
PILE TYPE HP 14x73

ORIGINAL THICKNESS: .506" WEB
ORIGINAL THICKNESS: .506" FLANGE

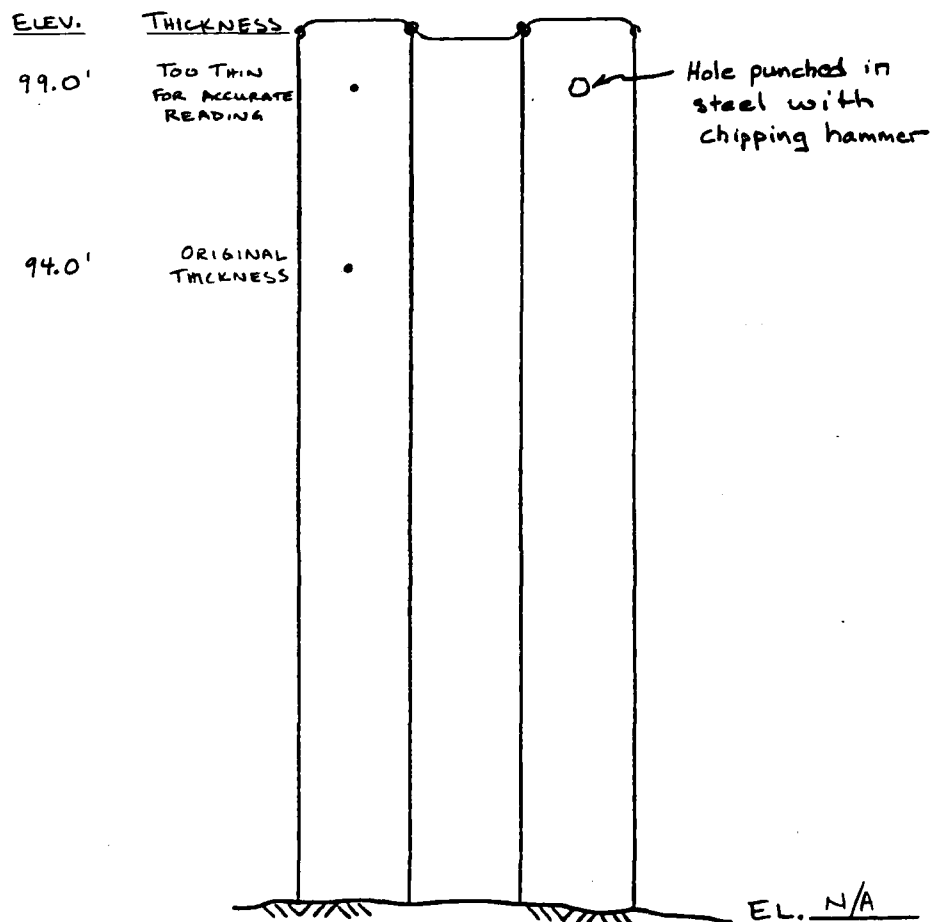
PILE TYPE M-112

ORIGINAL THICKNESS: .375"
